REPORT ON INSURANCE & FIRE SAFETY IN THATCHED PROPERTIES

THE DEPARTMENT of HOUSING, LOCAL GOVERNMENT & HERITAGE

November 2022

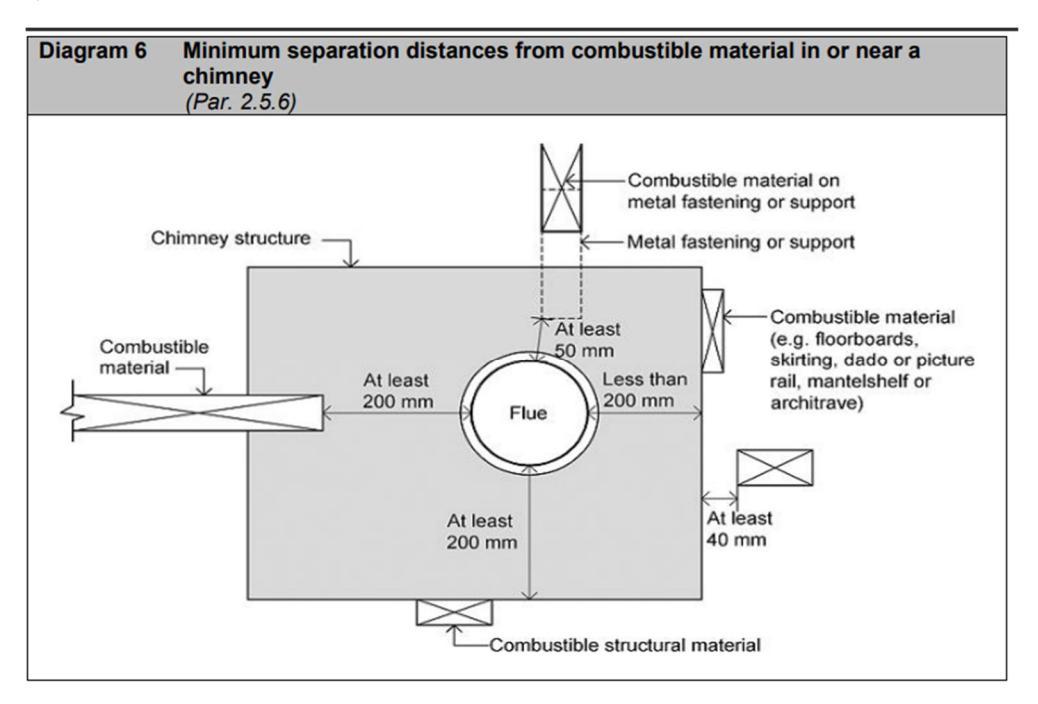
Metal fixings in contact with combustible materials should be at least 50 mm from a flue (see Diagram 6). 7

With some smaller chimneys, it is not possible to install a flue liner and maintain a 200mm distance between the inside edge of the flue liner and the combustible thatch without adding the 40mm air gap around the outside edge of the chimney. On larger chimneys where a distance between the inner surface of the flue liner and outer surface of the chimney stack of 200mm or larger can be achieved TGD J permits combustible materials to touch the outside of the brickwork.

(b) 40 mm from the outer surface of a chimney or fireplace recess unless it is a floorboard, skirting, dado or picture rail, mantelshelf or architrave.
